The Pediatric Elbow – Trauma – The Radiograph Revisited

Alan E. Oestreich, MD

Cincinnati Children's Hospital Medical Center, USA

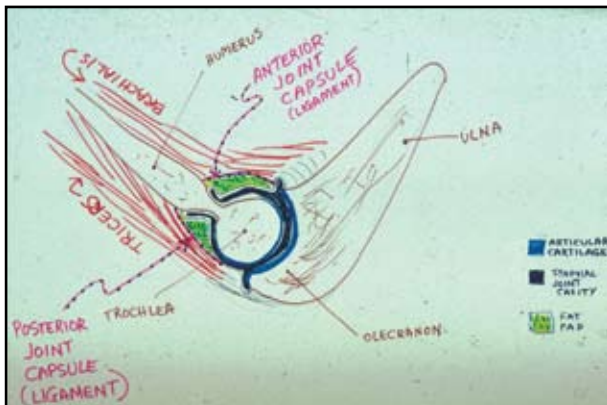
Figure 1. Diagram to demonstrate the anterior and posterior fat pads at the elbow (90 degree flexion lateral), after Cunningsham's Manual of Practical Anatomy. The posterior fossa of the distal humerus is deep, so that the fat external to the elbow joint normally remains in the fossa in this position. If the joint is swollen (from blood or infection fluid), the fat is pushed posteriorly and can be seen as a positive posterior fat pad sign, interfacing with the soft tissue density triceps. The anterior fossa is quite shallow, so the anterior fat external to the elbow is normally seen adjacent to the bone. It is pushed further from the bone when the joint is swollen, causing a positive displaced anterior fat pad sign. All three of the elbow bones are within the joint capsule, so fracture of any one or more of them results in a positive fat pad sign.

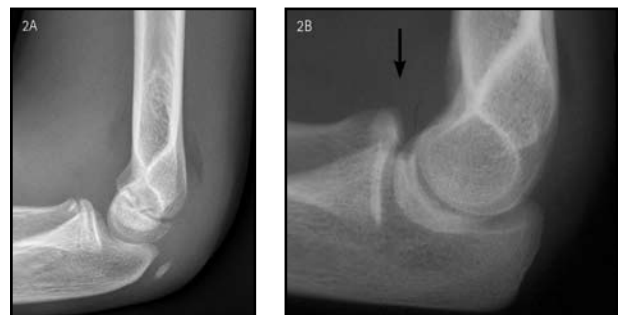
Figure 2. A. The positive posterior fat pad sign (arrowhead) after trauma suggests strongly that a fracture of at least one of the three bones is present. The anterior fat pad is also slightly displaced forward. Therefore, one should seek carefully for the fracture. In fact, the anterior tip of the coronoid process of the ulna is fractured and displaced to lie over the anterior metaphysis of the radius (arrow). B. An enlargement in slightly different position shows the olecranon tip fracture (arrow).

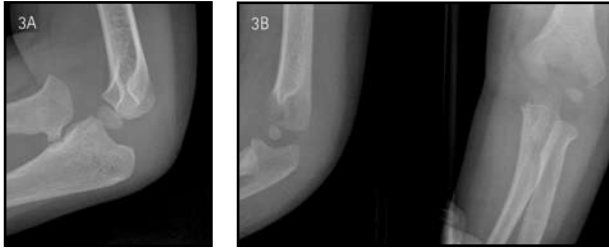
Figure 3. A. In this elbow radiograph, a positive posterior and a positive anterior fat pads are seen, but no fracture can be found. B. followup radiographs a few weeks later shows humerus metaphyseal bone destruction from osteomyelitis. Joint infection is also a cause of positive elbow fat pad signs.

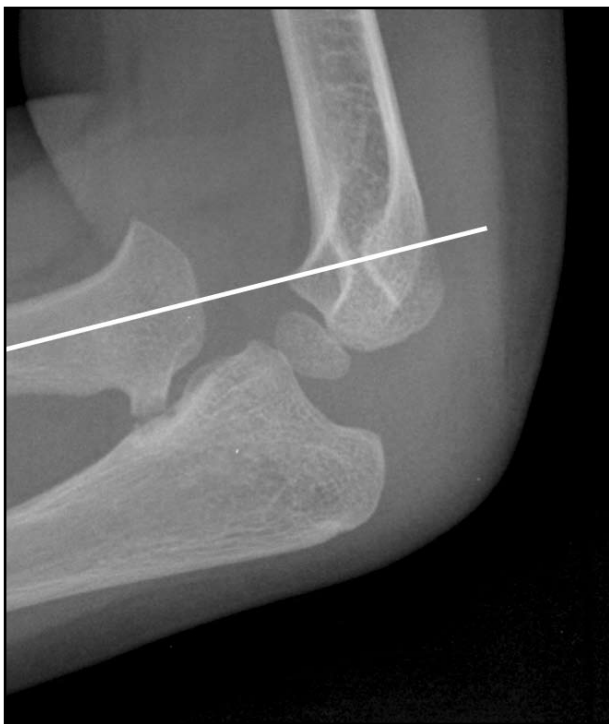
Figure 5. The radius-capitulum line (midshaft of radius) should traverse the capitulum in all projections. In this patient with congenital dislocation (and radioulnar near fusion) the line passes proximal to the capitulum.

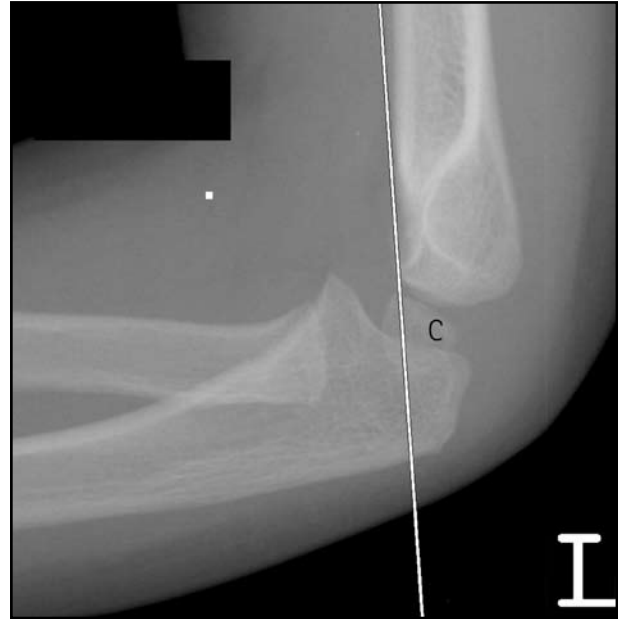
Figure 4. The anterior humeral line (shown in white) along the anterior shaft of the humerus on a lateral image should travel through the middle third of the capitulum (C). Here it traverses the anterior third of the capitulum in an elbow with a supracondylar fracture.

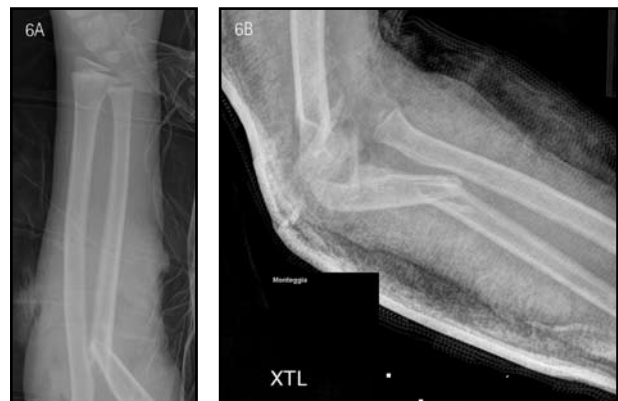
Figure 6. A. The radius dislocation of a Monteggia fracture may be missed if the elbow is not included on the radiograph, as in this image. B. The dislocation was detected and the elbow temporarily casted. Note the radius-capitulum line is much too anterior.

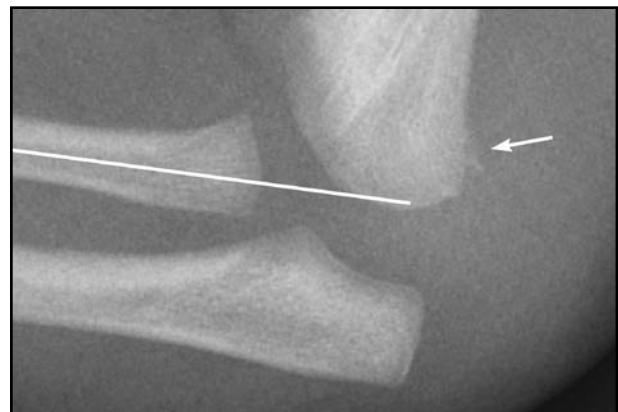
Fig. 7. In this 4 day old baby, the radius-capitulum line is directed away from the expected site of the cartilaginous capitulum, indicating a dislocation. Note also (small arrow) some avulsion of bone at the medial distal humerus.

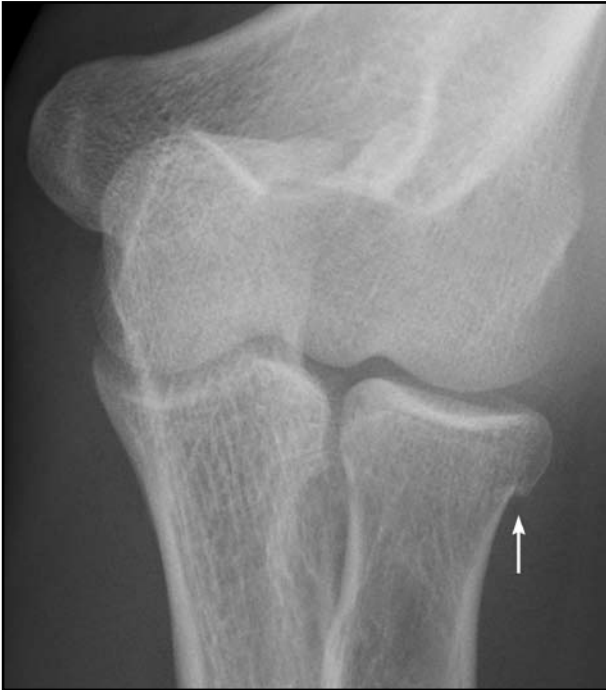
Fig. 8. Fracture of the radius neck (arrow) is revealed on a frontal view that has the radius and ulna lying parallel to the plate; while the humerus is foreshortened, being flexed because of pain (and thus not parallel with the plate). The positive fat pads led to this additional, successful, view.

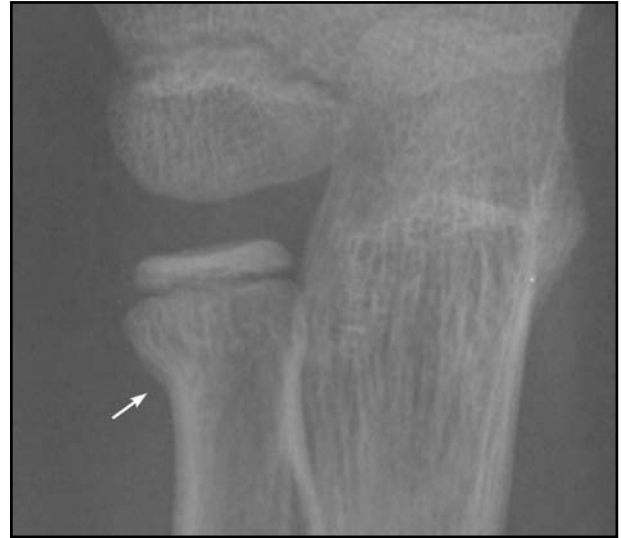
Fig. 9. Buckle fracture of the lateral radius neck (arrow) with subtle periosteal reaction from an injury over 10 days previously.

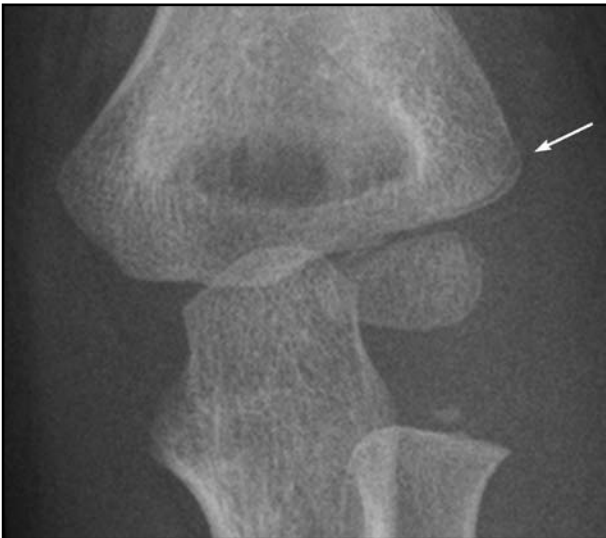
Fig. 10. Salter 2 or Salter 4 lateral condyle fracture of the humerus (arrow). Without MRI, one cannot tell if the fracture line extends through epiphyseal cartilage, which would make it Salter 4; if it does not so extend, it would be Salter 2.

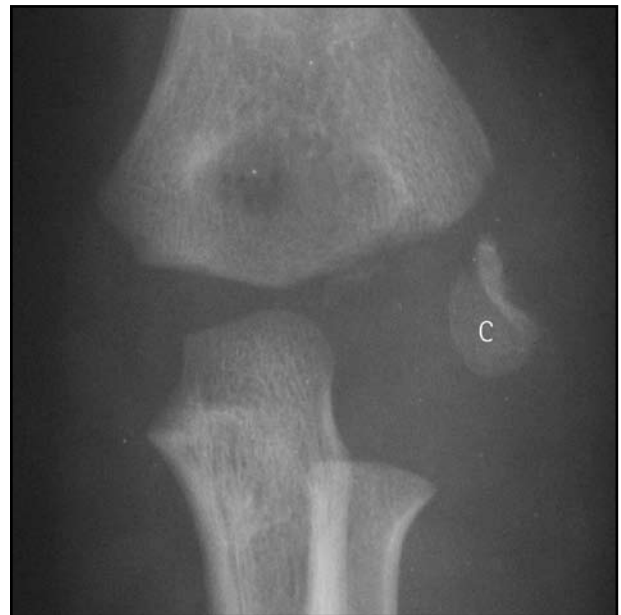
Fig. 11. This lateral condyle fracture involves displacement of the capitulum (C) and a bit of adjacent metaphysis with considerable rotation in the coronal plane. Surgical correction, hopefully in timely fashion, is necessary.

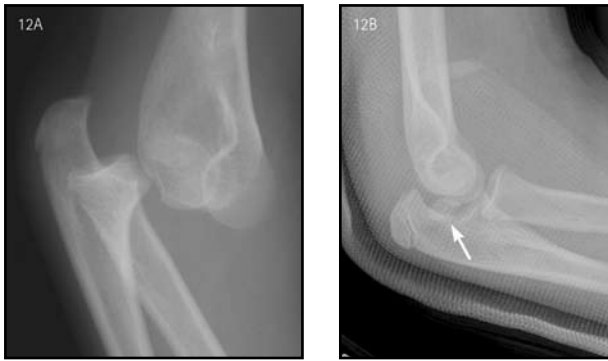
Figure 12. A. A dislocation at the elbow is clearly evident, but a possible avulsed fragment is not as clearly seen. B. After reduction and casting, the avulsed fragment is seen (arrow) and is „trapped” in the elbow joint, requiring surgical correction. The postreduction images should always be done before casting, to rule out such a trap.

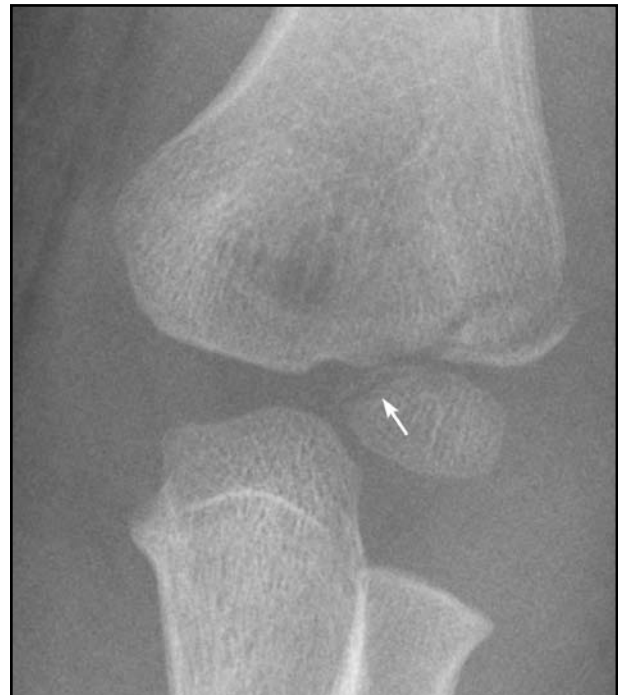
Figure 13. This fracture of the humerus lateral condyle is seen to traverse the medial capitulum (arrow), so that its being Salter 4 is evident on plain image.

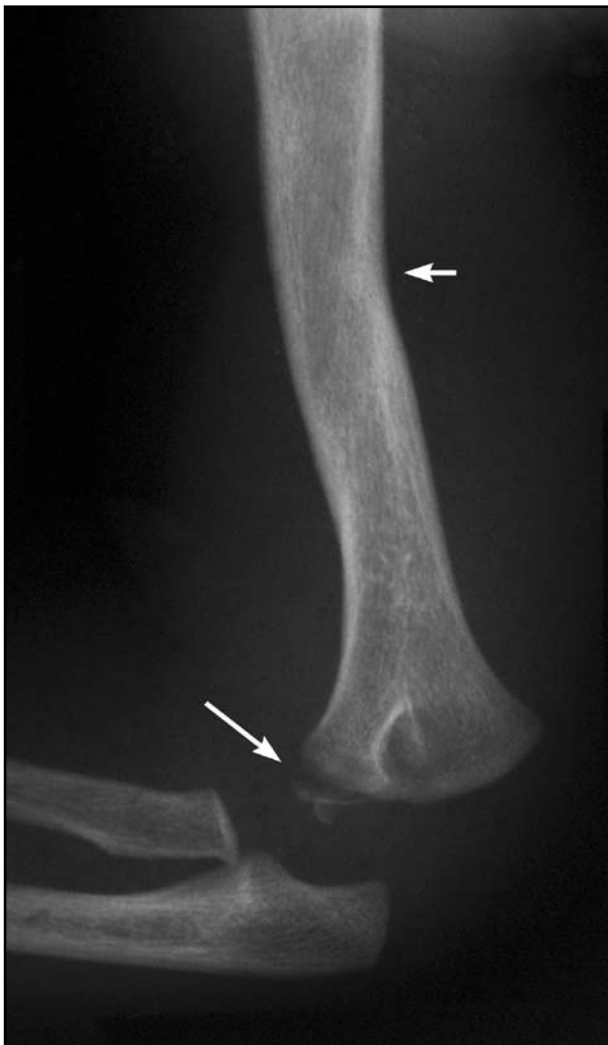
Figure 14. „Look everywhere else!” In this 13 month old child, in addition to the lateral condyle fracture (long arrow), deformity from a prior midshaft fracture (at age 7 months) can be seen when one looks more proximally (short arrow). This is further evidence of child abuse in an infant who was returned originally to his home.

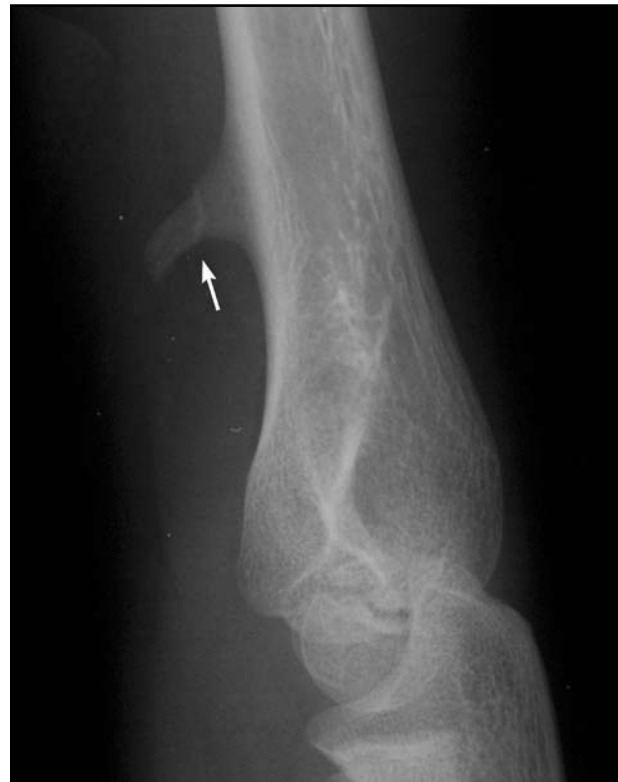
Figure 15. Fracture (arrow) of a supracondylar process in an 11 year old boy with an American football injury. The median nerve and artery lie near supracondylar processes. The process is a relatively uncommon normal variation.

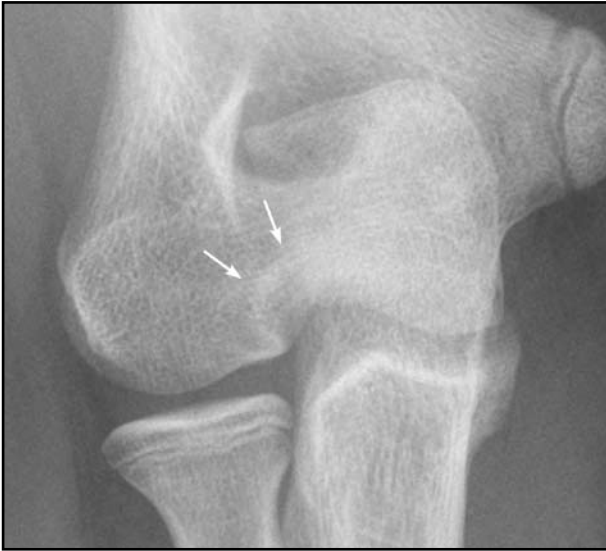
Figure 16. The irregularity of the distal contour of the trochlear region (arrows) medial to the capitulum is indicative of a traumatic osteochondral lesion (in a vascular watershed area – see reference [1]).

Figure 17. Similar to the lesion of Figure 16 is a small fracture of the most medial capitulum.

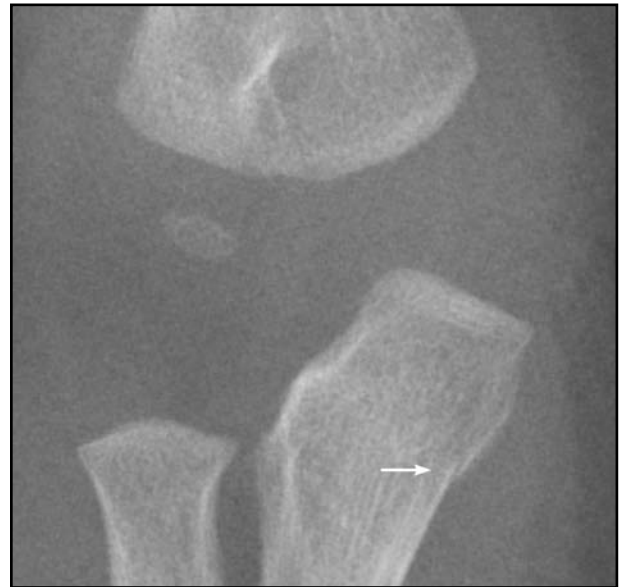
Figure 19. Subtle longitudinal ulna fracture (arrow). Attention to detail, especially if a fat pad or the anterior humeral line or the radius-capitulum line is abnormal, may assist the medical imager in locating and in diagnosing elbow fractures.
